Restoring biodiversity in Nicaragua's national reserve with ultrasound

Eutrophication

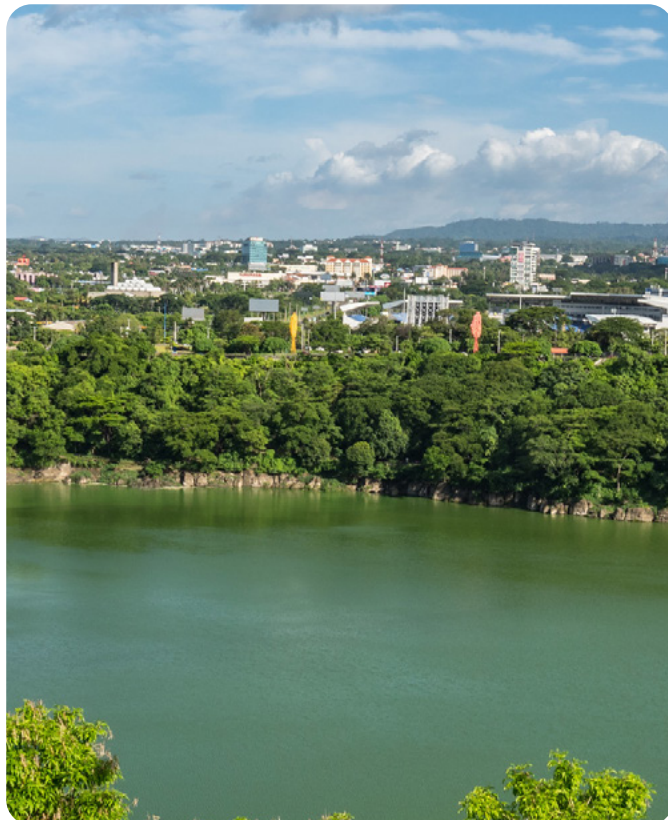
Fig 1. Tiscapa lagoon before treatment in November 2019.

Unfortunately, approximately four decades ago, the Tiscapa Lagoon became a discharge site for various pollutants, ranging from solid waste to untreated sewage. This alteration in water quality led to an accumulation of organic matter, resulting in eutrophication of the lake.

The consequences of eutrophication were severe, setting off a domino effect that degraded water quality. The proliferation of algae formed a thick green layer on the water's surface, blocking sunlight from reaching the bottom of the lake.
